## G503 WWII Military Jeep Radiator Rebuild Restore WW2 Restoration

This article shows a step by step process of restoring your G503 WWII Jeep Radiator - By Lew Ladwig

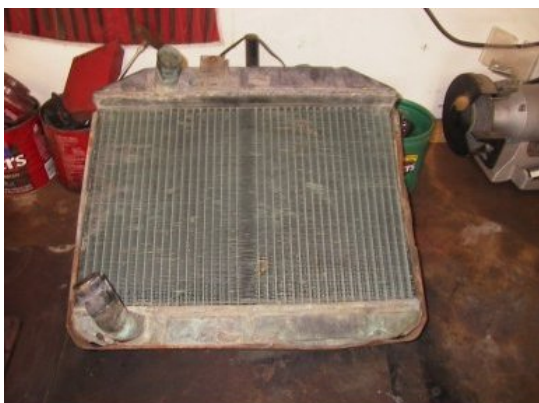
I found a good GPW radiator. Most of the thin fins are bent over but the tubes look to be OK. It has the correct 45 cut on the sides and the center missing tube. The tanks have several dents and the bottom tank is bulged out. This is probably due to freezing. My plan is: 1) Measure frame 2) remove frame 3) remove tanks 4) clean and rod 5) pound out tank dents etc. 6) straighten fins - remove tarnish 7) resolder 8) add shroud 9) add over flow tube 10) paint 11) zinc plate carriage bolts

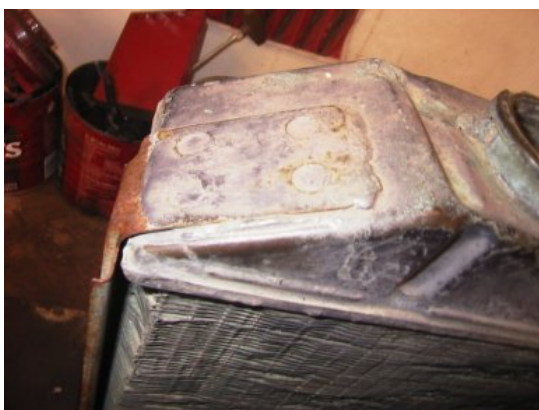
You can see where the frame is soldered to the top tank, there is also solder along the bottom and the lower corner tabs. Mine had broken the solder joint at the corners and most of the bottom.

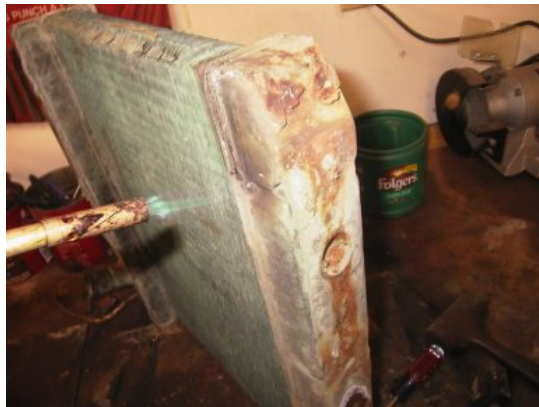
Here I am sweating the solder from the lower tank seam. Let gravity do much of the work. As you heat things up the two parts tend to separate with the heat. Be patient. I used a putty knife to scrape hot solder out of the joint. Worked for about 20min but did not have it apart yet. Another 10min should do it. The last radiator I did this on it came apart in about 20min or so. Just look for areas that are still soldered. Heat them up and work as much solder out of the joint as you can and wiggle the joint as it cools so it does not rejoin.

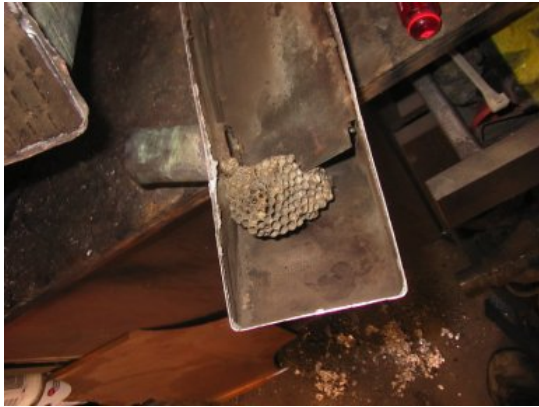
With the top off, look what we found, a wasp nest! Do you think a can of prestone flush would have removed that?

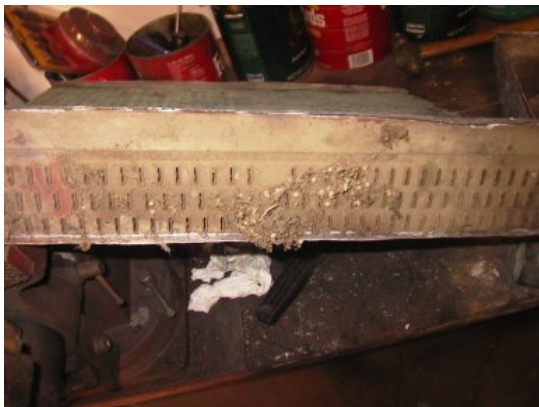
Lots of dirt and junk in the top:

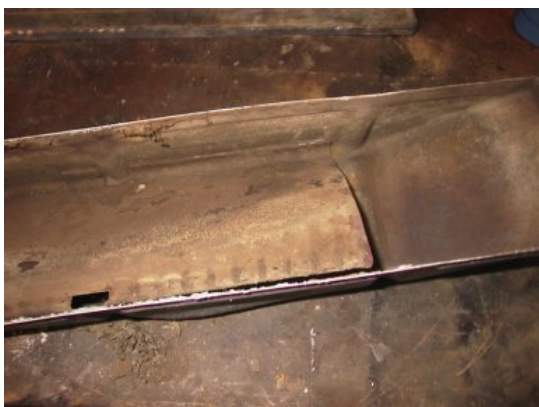
Baffle was loose in most parts:
